LEBANON 044/103

I-89 SB over CONNECTICUT RIVER, NECRR

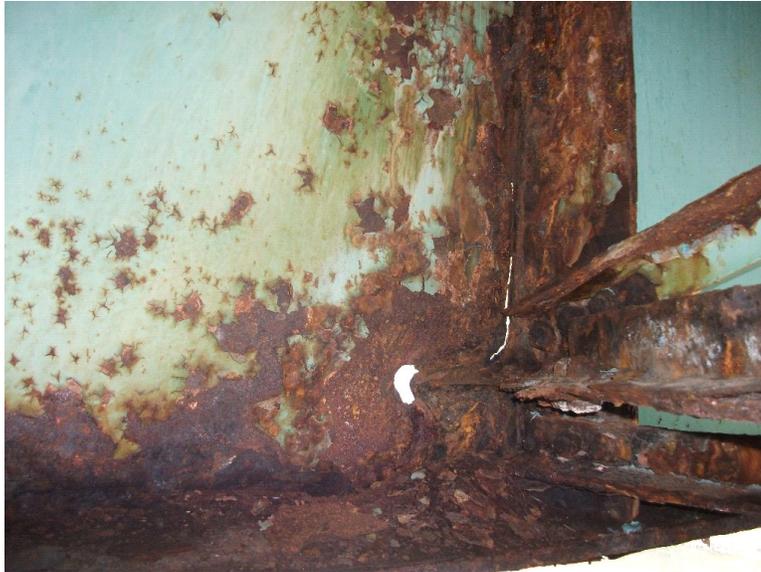
B416 67

INSIDE VIEW OF CRACK
AND HOLE IN GIRDER #1,
SPAN #3 UNDER RELIEF
JOINT.

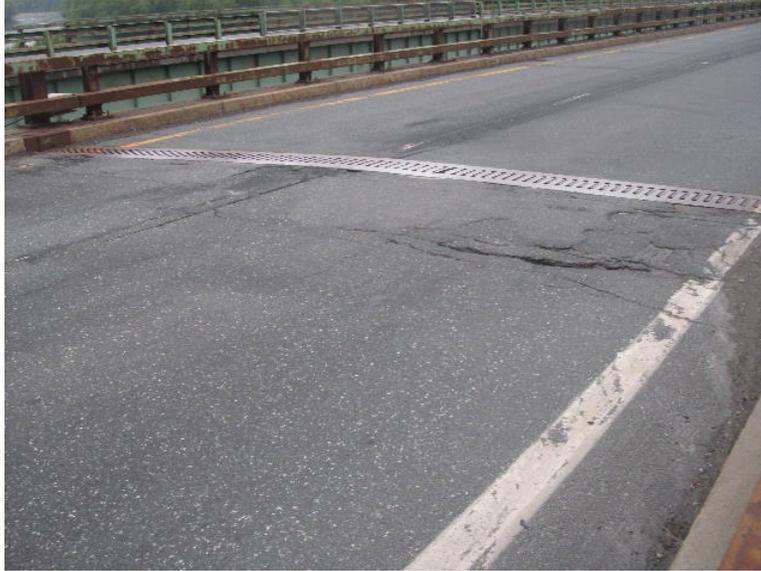
B399 02

NORTHWEST APPROACH IN
SOUTHBOUND LANE,
CRACKED SETTLED AND
PATCHED.

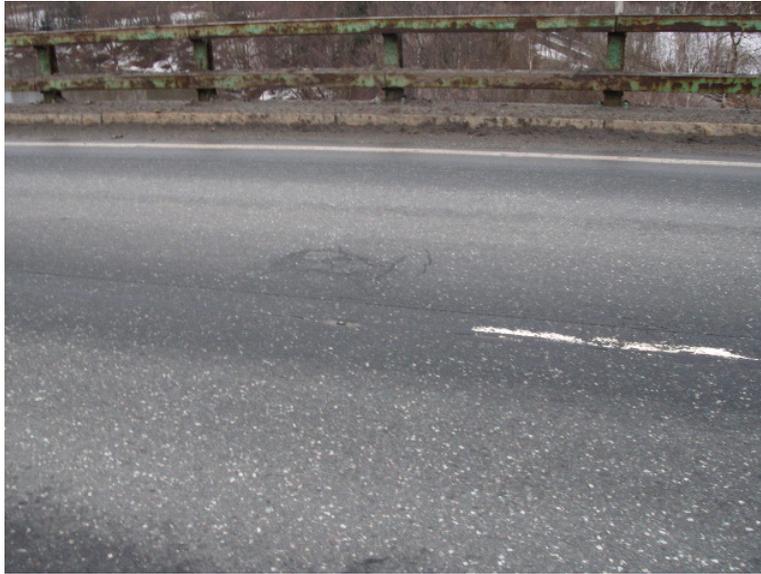
B360 10

ASPHALT CRACKED AND
DEPRESSED IN SPAN FIVE
NEAR CENTERLINE.

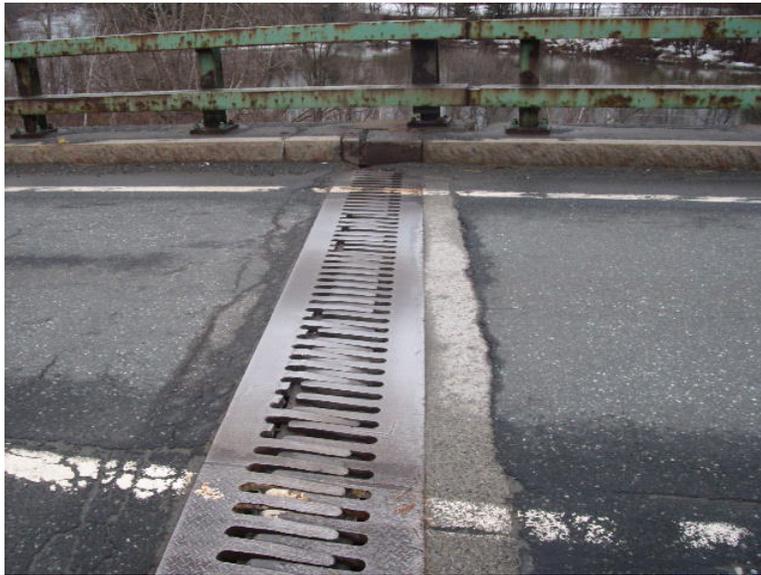
B360 11

NINE BROKEN FINGERS AT
SOUTH END.

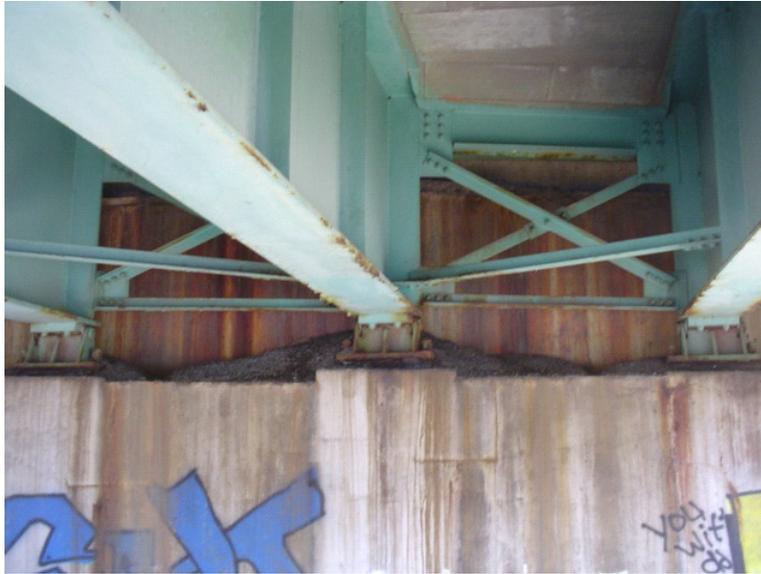
A220 10

TYPICAL HEAVY DIRT BUILD UP AT NORTH ABUTMENT BEARINGS.

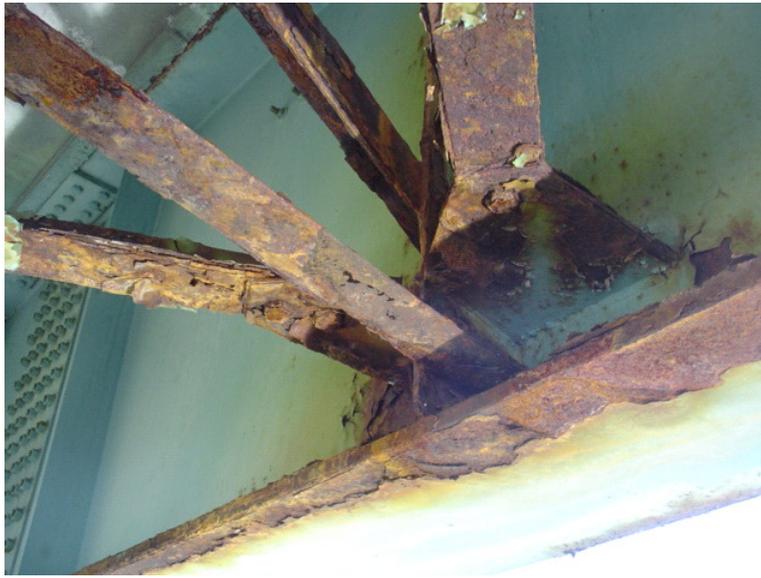
A220 11

HEAVY SECTION LOSS TO BRACING FRAME AND GUSSET PLATE, GIRDER #5, SPAN #4 UNDER RELIEF JOINT.

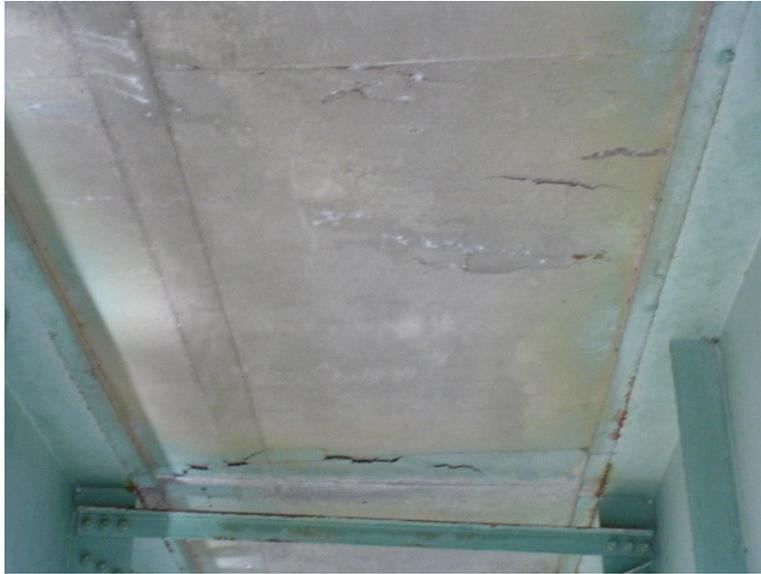
A220 13

TYPICAL MODERATE
DELAMINATIONS IN
UNDERSIDE OF DECK.

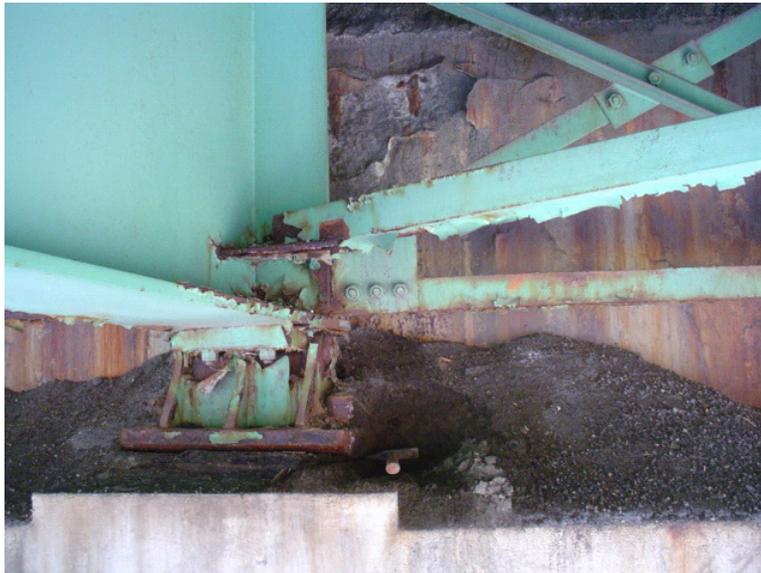
A220 14

VERY HEAVY DIRT BUILD
UP WITH BEARING #3
LIFTED 1/4 +/- INCH.
TYPICAL MODERATE
SPALLS IN BACKWALLS.

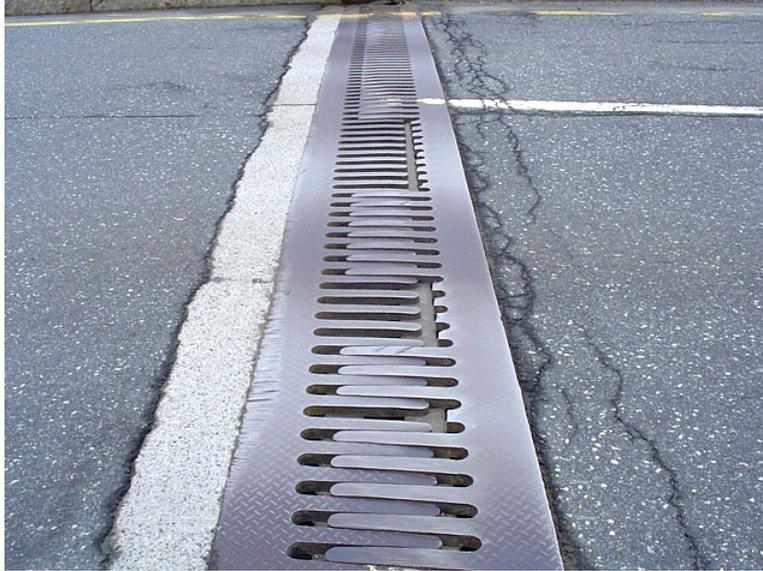
A197 013

15 BROKEN FINGERS ON
SOUTH JOINT.

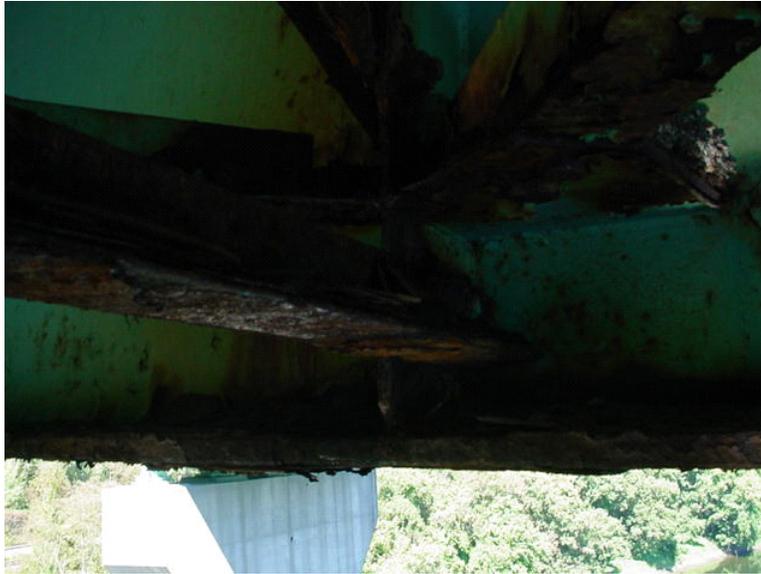
A163 12

HEAVY SECTION LOSS TO
GUSSET PLATE AND
BRACING ANGLES ON
UPSTREAM EXTERIOR
GIRDER UNDER RELIEF
JOINT SPAN #4; INNER
FLANGE RUSTED TO 15/16
INCH AT EDGE.

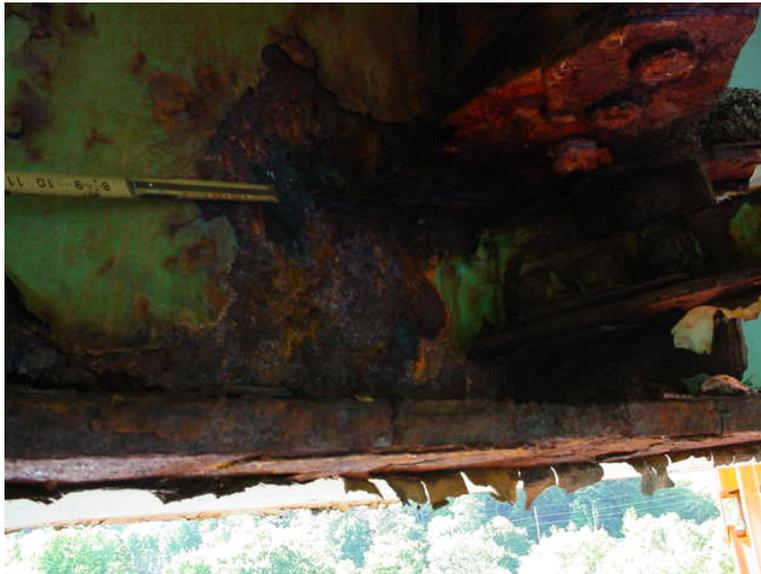
A163 13

HEAVY SECTION LOSS TO
GUSSET PLATE AND
BRACING ANGLES WITH
GIRDER WEB NEARLY
RUSTED THROUGH ON
DOWNSTREAM EXTERIOR
GIRDER UNDER RELIEF
JOINT SPAN #3.

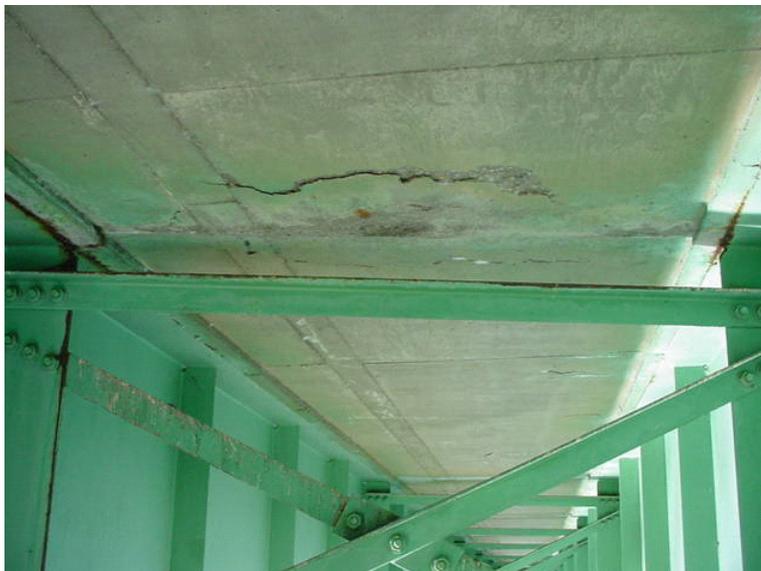
A163 14

TYPICAL UNDERSIDE
CONDITION OF MEDIUM
DELAMINATIONS IN AREAS
OF DECK.

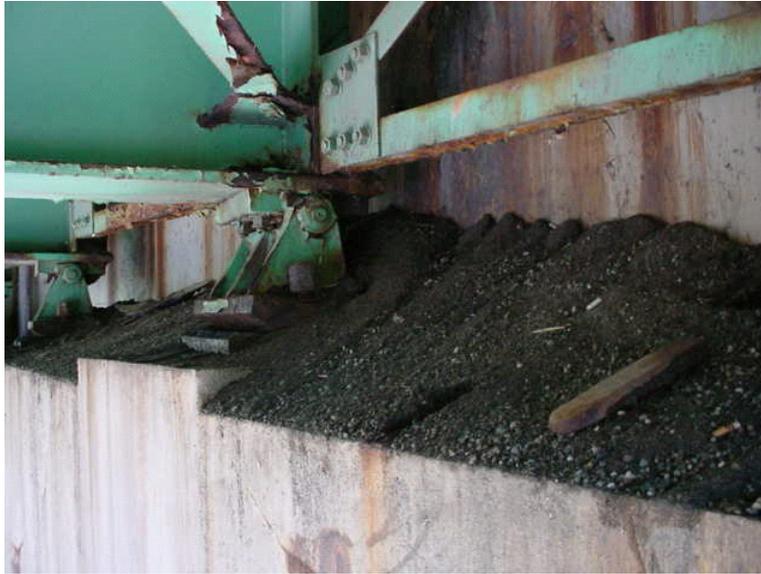
A163 15

HEAVY DIRT BUILD UP
AROUND SOUTH
BEARINGS. TYPICAL AT
NORTH ALSO.

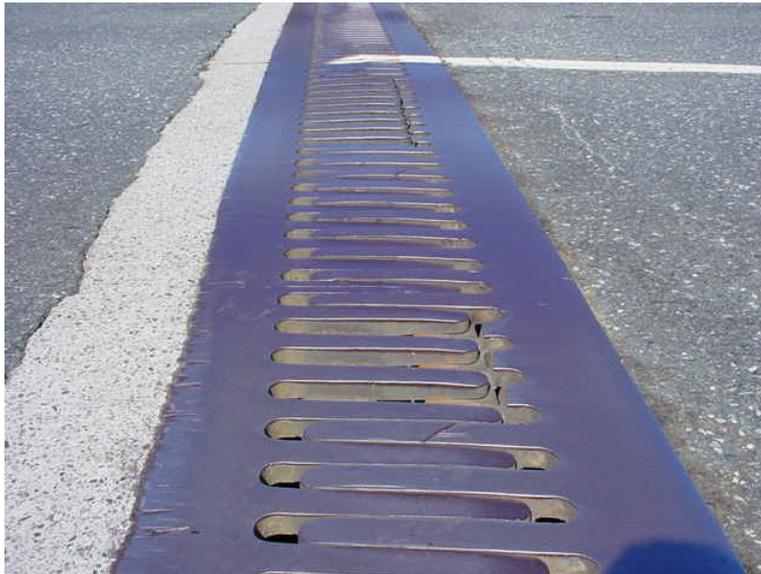
A163 16

12 BROKEN FINGERS IN
SOUTH EXPANSION JOINT.

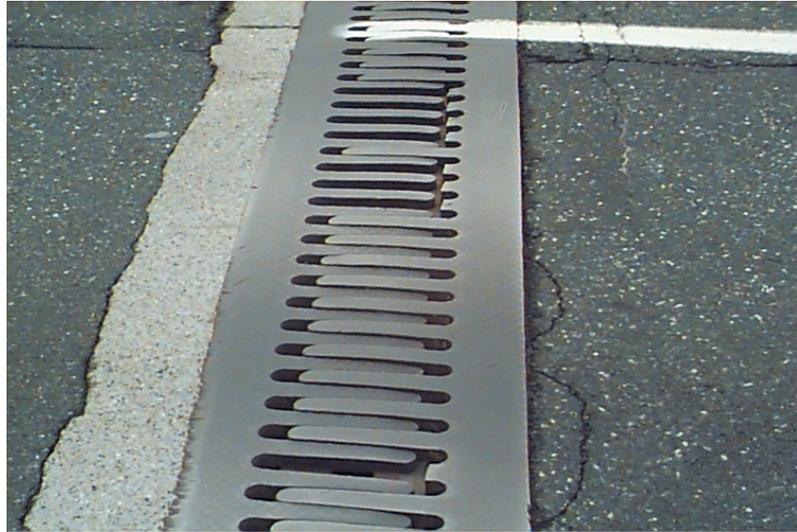
A116 25

EIGHT BROKEN FINGERS
AT SOUTH JOINT.

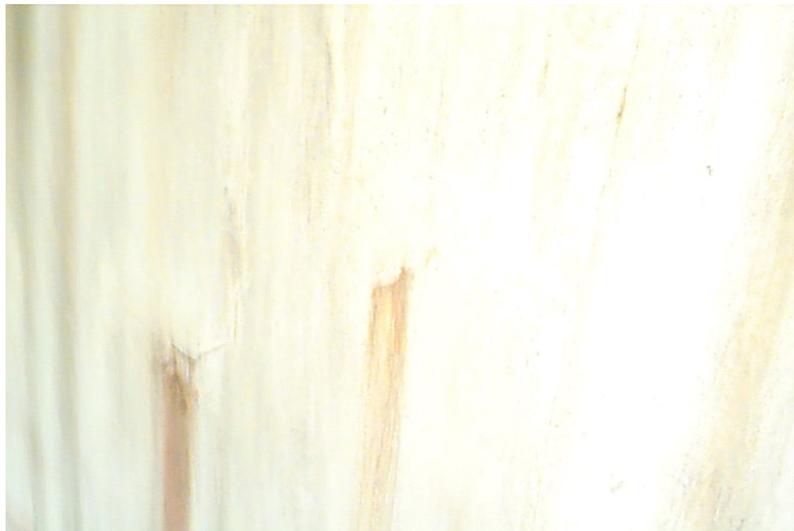
A047 34

DEBRIS ON SEAT,
BEARINGS RUSTED WITH
SECTION LOSS ON ANCHOR
BOLTS, BACKWALL
SPALLED. TYPICAL AT
SOUTH END.

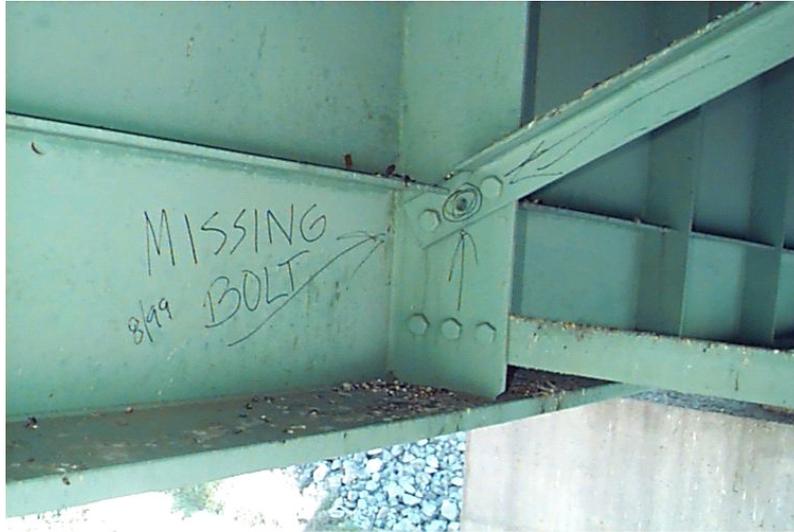
A047 35

MISSING BRACING BOLT IN
FRAME #2 AT GIRDER #4 IN
SPAN #2.

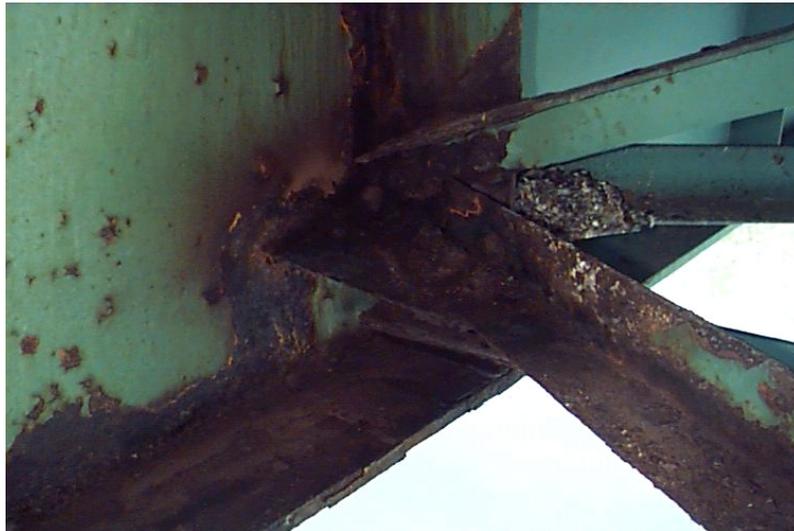
A047 36

SECTION LOSS AND HEAVY
RUST UNDER SPAN #3
RELIEF JOINT. BRACING
GUSSET HOLED AT GIRDER
#1.
